ENERGY EFFICIENT ENGINE

PIN FIN AND CERAMIC COMPOSITE SEGMENTED LINER

COMBUSTOR SECTOR RIG TEST REPORT

UNITED TECHNOLOGIES CORPORATION
Pratt & Whitney
Engineering Division

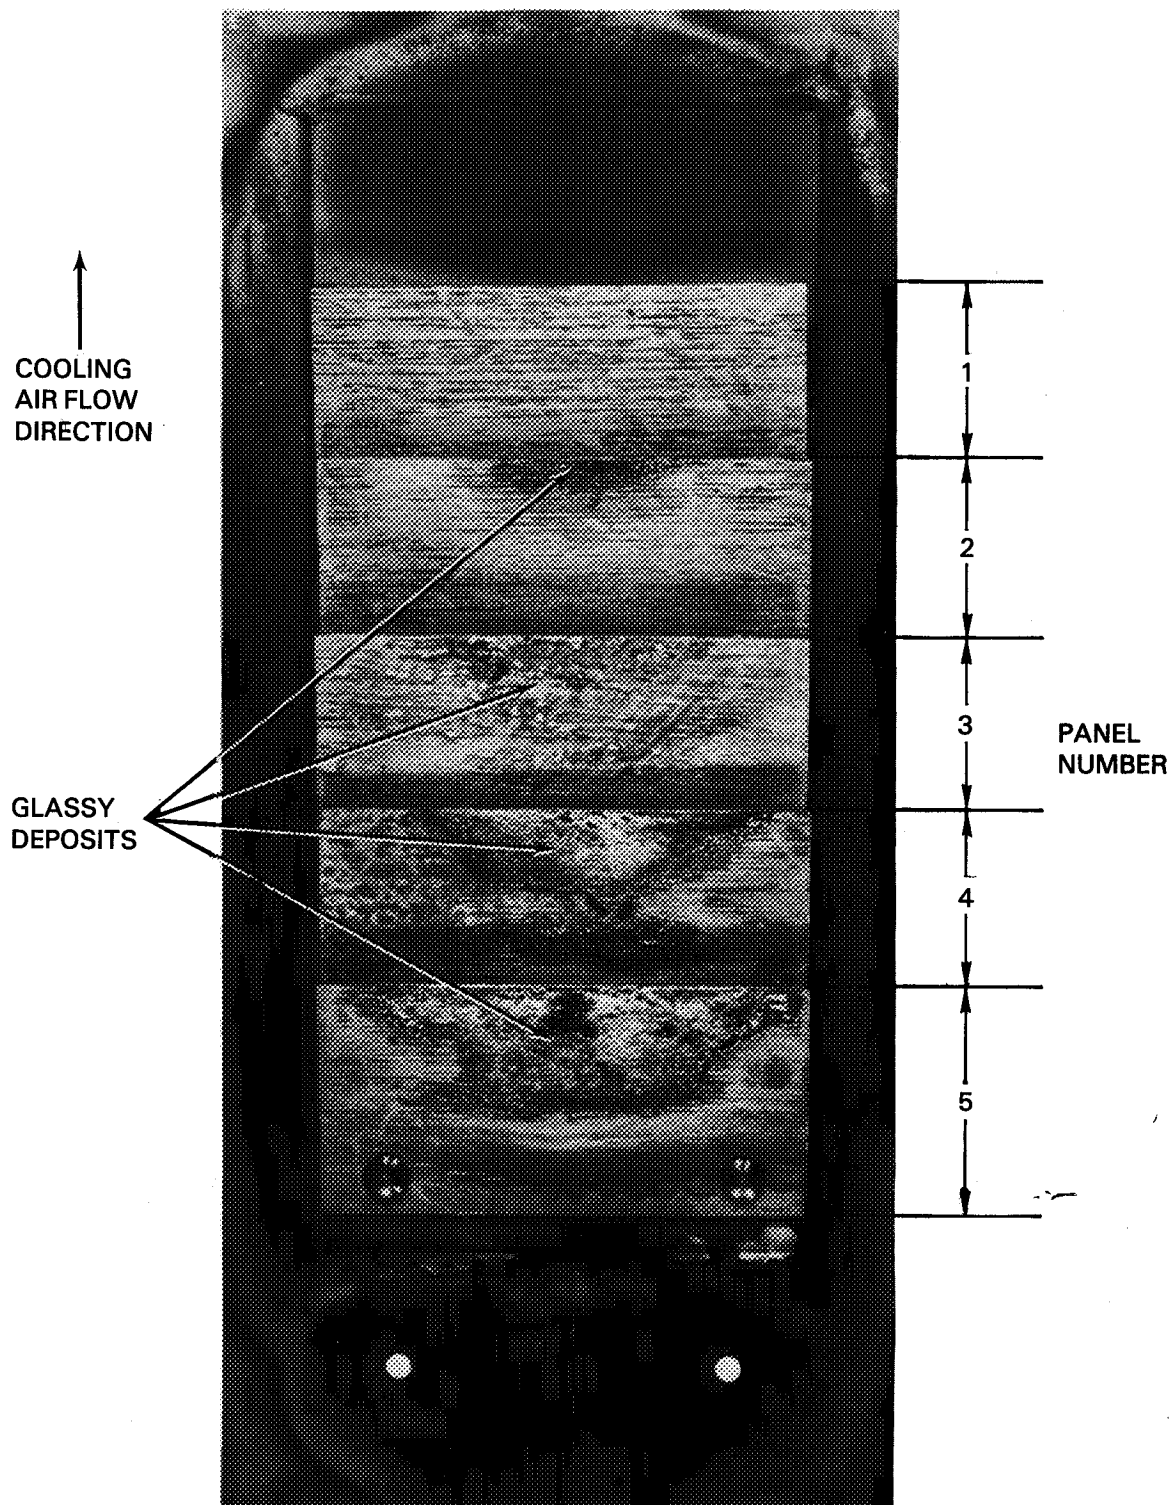
Figure B-19 SiC-LAS III Panels in Test Fixture After 100-Hour Thermal Durability Test

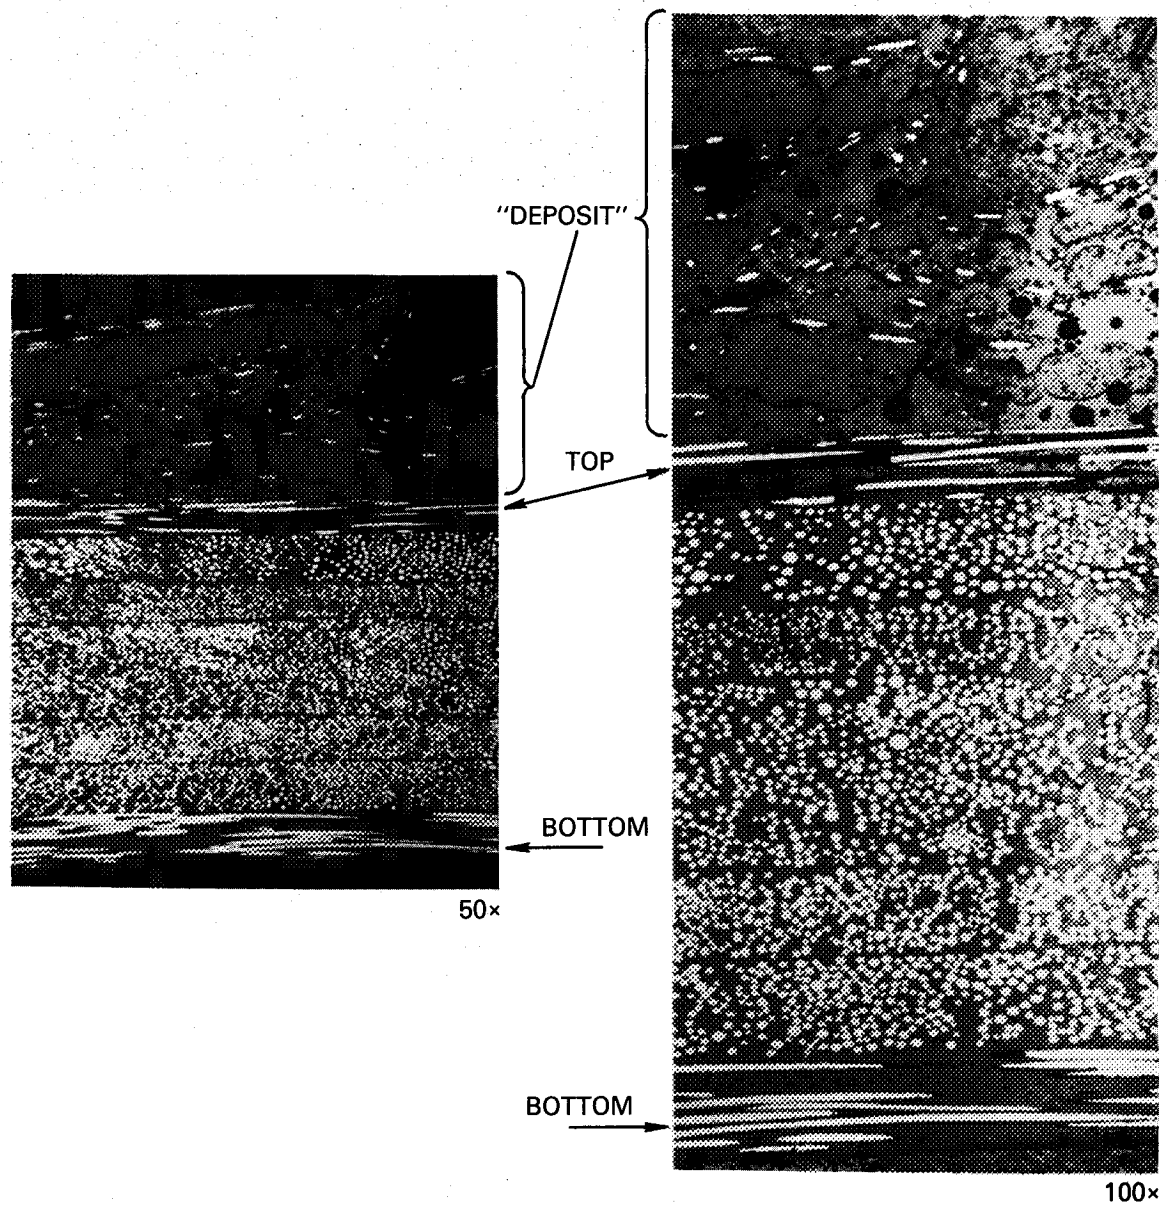
Figure B-22 Photomicrograph of a Transverse Section through SiC-LAS III
Panel 3 Showing "Deposit" Layer
